TB 172

## TECHNICAL BULLETIN

**Product :** Midilift Piccolo (2:1 roped models)

**Subject :** Stump post packers

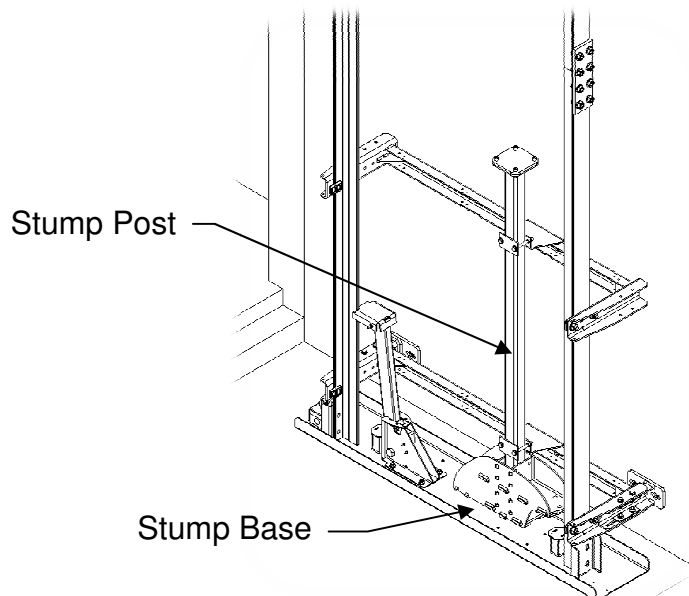
The Midilift Piccolo 2:1 roped hydraulic platform lift features a stump assembly underneath the hydraulic ram. The stump post locates in a square aperture in the middle of the stump base.

During installation, it is sometimes necessary to install packers below the stump post. These packers should be located on the **lower** plate of the stump base, with the stump post sitting on top of the packers.

A recent installation has highlighted that it is possible for the packers to be installed incorrectly, whereby the packers are resting on the upper plate rather than the lower plate. This results in the stump post being inadequately supported at an elevated position.

**Installation Engineers** – packers must be installed correctly, as per the extract from the installation guide shown below. This includes any lifts that are part installed but yet to be commissioned and handed over.

**It must be confirmed that the stump post passes through the upper plate of the stump base** (as per image overleaf).

If packers can be seen instead of the top plate then the lift must be removed from service until corrective work can be undertaken.
