STANNAH LIFTS LTD

TECHNICAL BULLETIN

For the Attention of :		Service Engineers, Training Dept
Date :	18/11/2009	
Product :	MRLi Passenger Lifts	
Subject :	Pawl Device Retrofit Kits on lifts with 2 car entrances	
Pages :	1	
Originator :	Stannal	n Lifts Ltd, Anton Mill, Andover, Hants SP10 2NX 01264 339090

TB87 rev A = Change to SRA wiring

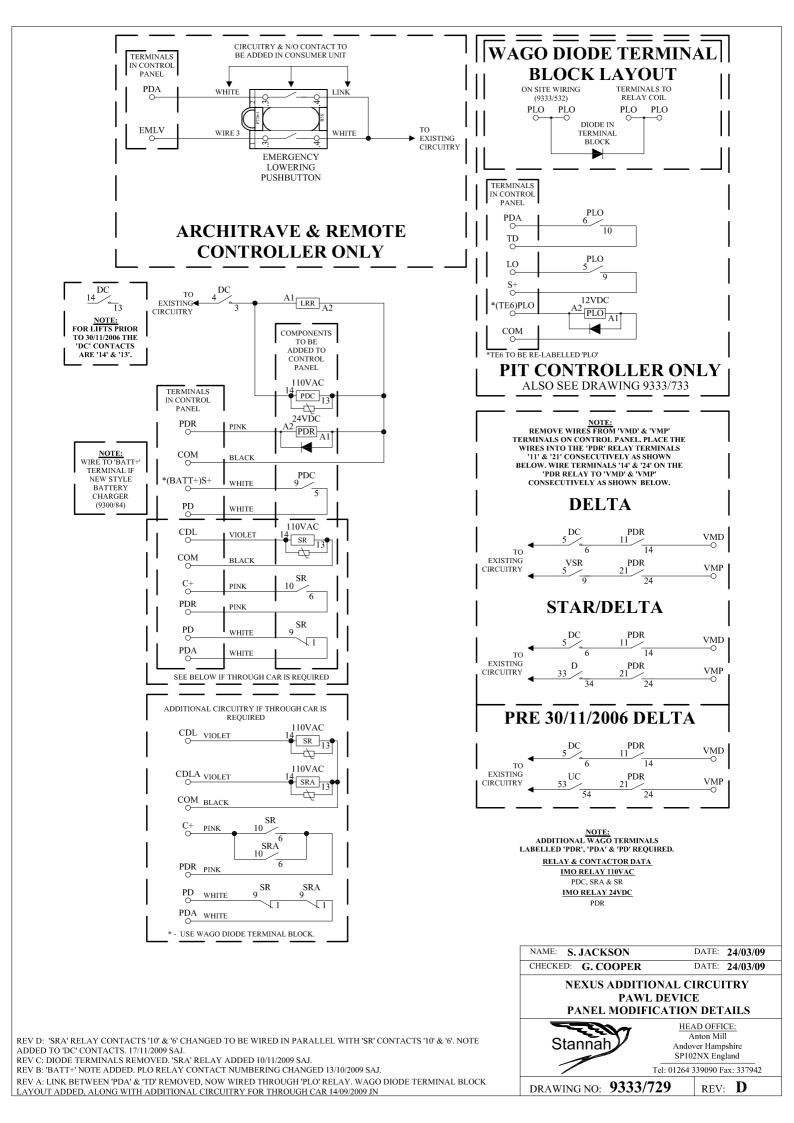
Attachment: - 9333/729 rev D

Following the original issue of this bulletin an error has been found on drawing 9333/729 revision C whereby the SRA relay wiring was shown incorrectly (see diagram below).

Note: the schematic diagram supplied (1009239 rev A) shows the correct wiring of the SRA relay.

- 1. SRA relay on MRLi's with 2 car entrances to be wired in accordance with the above diagram (or 9333/729 revision D or 1009239 rev A).
- 2. A paper copy of 9333/729 revision D must be stored on site (2 car entrances only). Earlier revisions of 9333/729 and 1009239 should be discarded.

No extra parts are required - this is a wiring change only.
