**TB 185**

## **TECHNICAL BULLETIN**

**Product :** Midilift GL, SL, SLplus & XLplus

**Subject :** Installers Working Platforms - Back Frame Non-Conformance

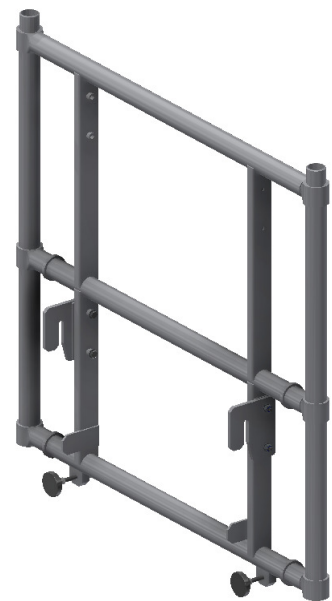
On these incorrectly manufactured back frames, the fixing points for the hook plates were positioned too high up. The manufacturer subsequently trimmed the top of the hook plates off to permit the back frames to be used.

This deviation was never approved by Stannah Lifts and as such has never been subjected to formal approval or verification tests. As a result, the structural capacity of the hook plate cannot be deemed sufficient without a thorough review first taking place.<sup>1</sup>

**Therefore, any platform with an incorrect back frame must be withdrawn from use immediately until further notice.**

1. Custodians of working platforms must measure and report some key dimensions that will enable Stannah Lifts to determine if the back frame is correct or not – see Appendix A of this bulletin.
2. Incorrect back frames must be withdrawn from use immediately (all products) until further notice. \*

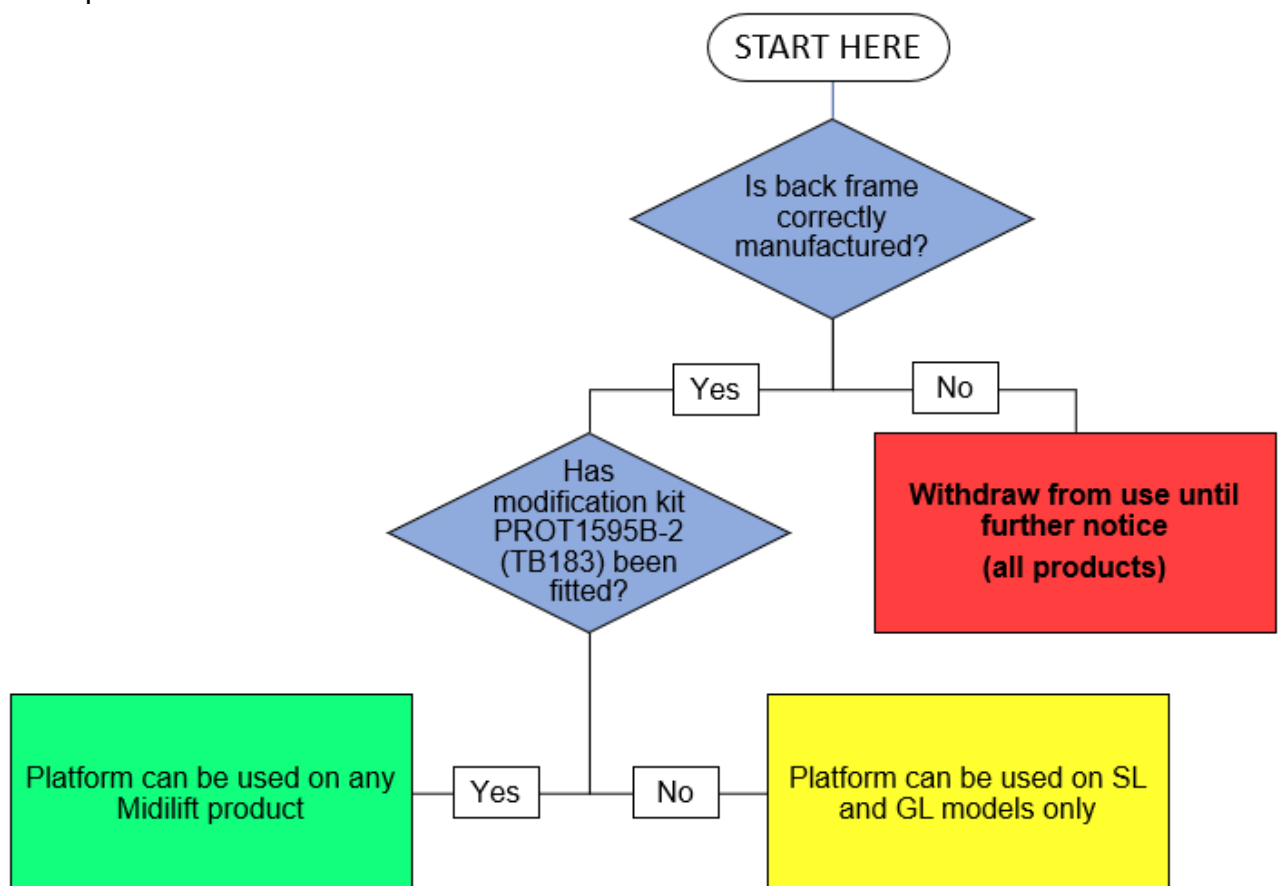
Graphical overview of actions:

3. Working platforms with correct back frames can continue to be used on Midilift SL and GL products only. Stannah Lifts will then supply the hook plate modification kit and once this has been fitted these working platforms can be used on any Midilift product. Refer to TB183 for full details of this kit.

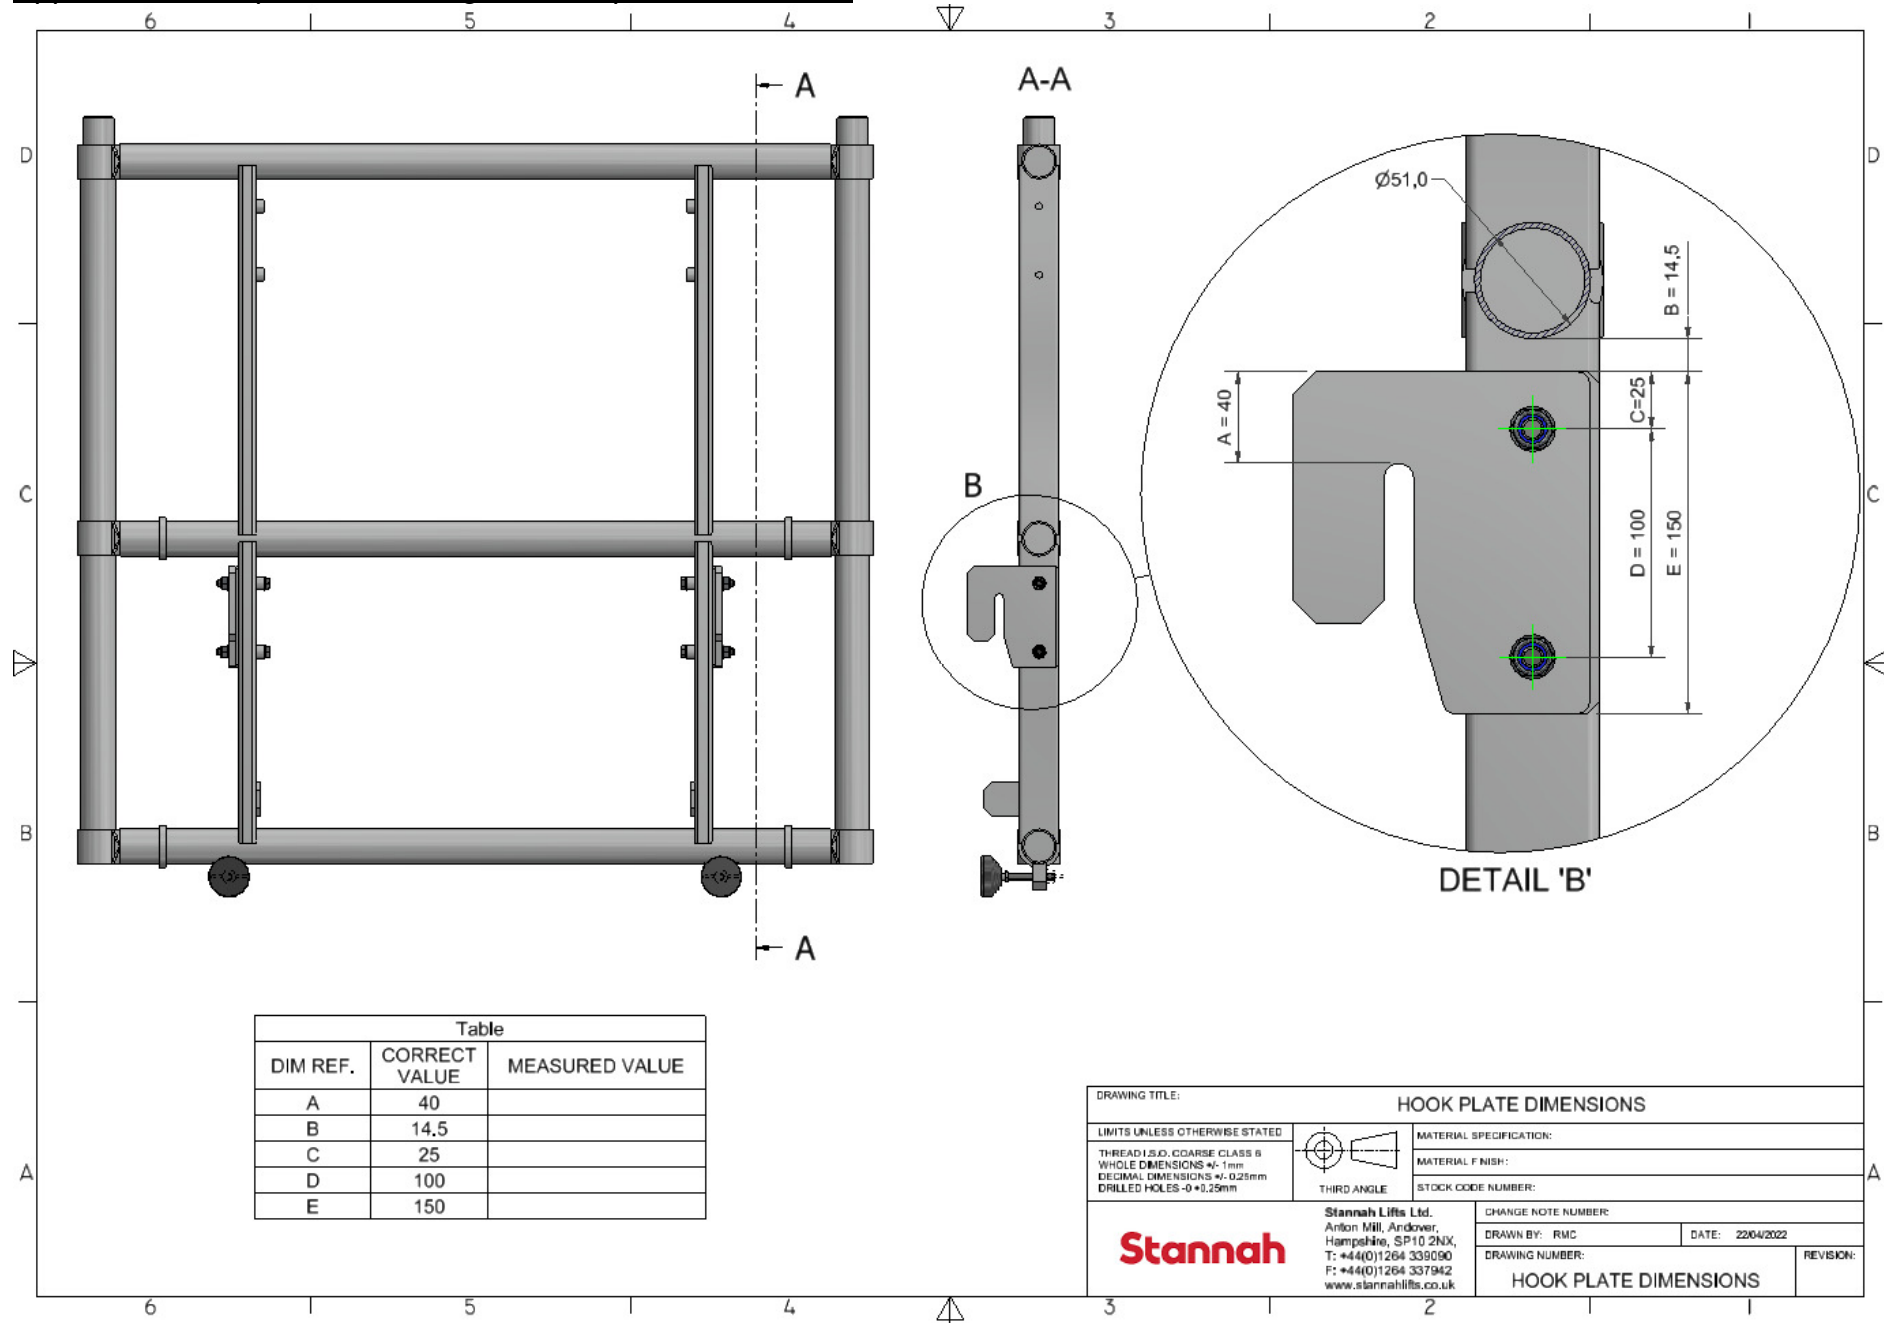
Appendix A – Inspection drawing for hook plate dimensions

Please inspect each platform in your remit and report dimensions A through to E at the earliest opportunity (see Appendix A of this bulletin). **Until a platform is confirmed as having a correct back frame it must not be used until further notice.**
